Study on Performance of Road Signs and Markings along TANZAM Highway in Mbeya Region, Tanzania

Duwa Hamisi Chengula*

*Mbeya University of Science and Technology, College of Engineering and Technology, Department of Built
Environment Engineering. P.o.Box 131 Mbeya, Tanzania
Email: chengula@yahoo.com*

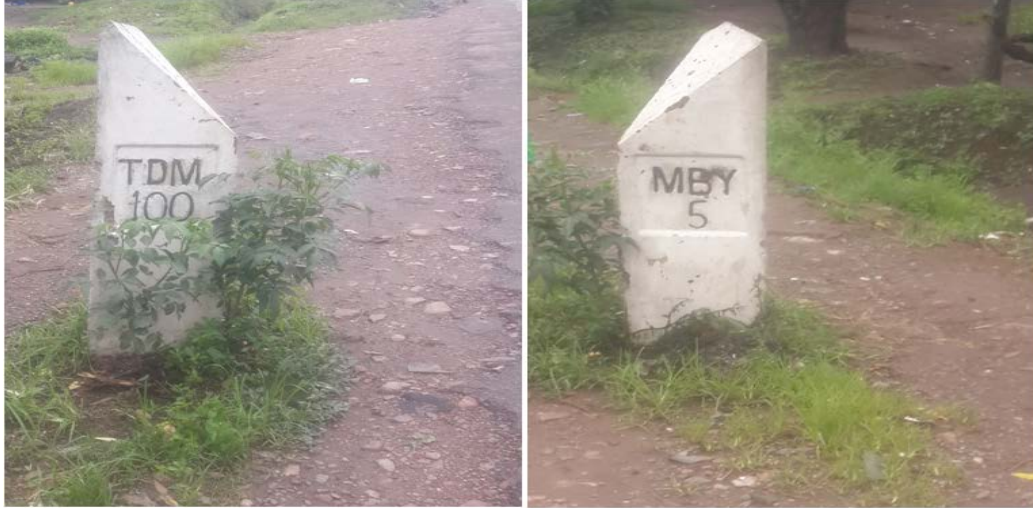
However the whole study road segment from Uyole to Iyunga only one milestone exist which is located at coordinate E543816 N9013666. The road sign was found to be under size, not reflective, defected, poor legend and partly hided with shoulder grasses (figure 3.2). The milestones are among of the important guidance sign for drivers especially none regular road users because milestones help to indicate the distance covered and remaining distance to destination but also they provide information of the locations.

Figure 3.2: Milestone at coordinate E543816 N9013666 showing its both sides

The author of this article suggested an alternate installation of milestones along TANZAM highway in Iringa region in 2016 when implementing a project of installation of road signs and reflective zebra crossing along TANZAM highway in Iringa, the project under TANROADS Iringa region. During implementation of the project the milestones were installed on both directions of road at an interval of 10KM zigzag on each side for

the purpose of assisting drivers and other road users from both directions to recognize the covered distance, remaining journey and current location. The traditional practice was to install the milestones on one side of the road and normally left hand side at an interval of 5KM. The alternate installation of road signs is being implemented in most of the new roads and rehabilitation of road projects in Tanzania.

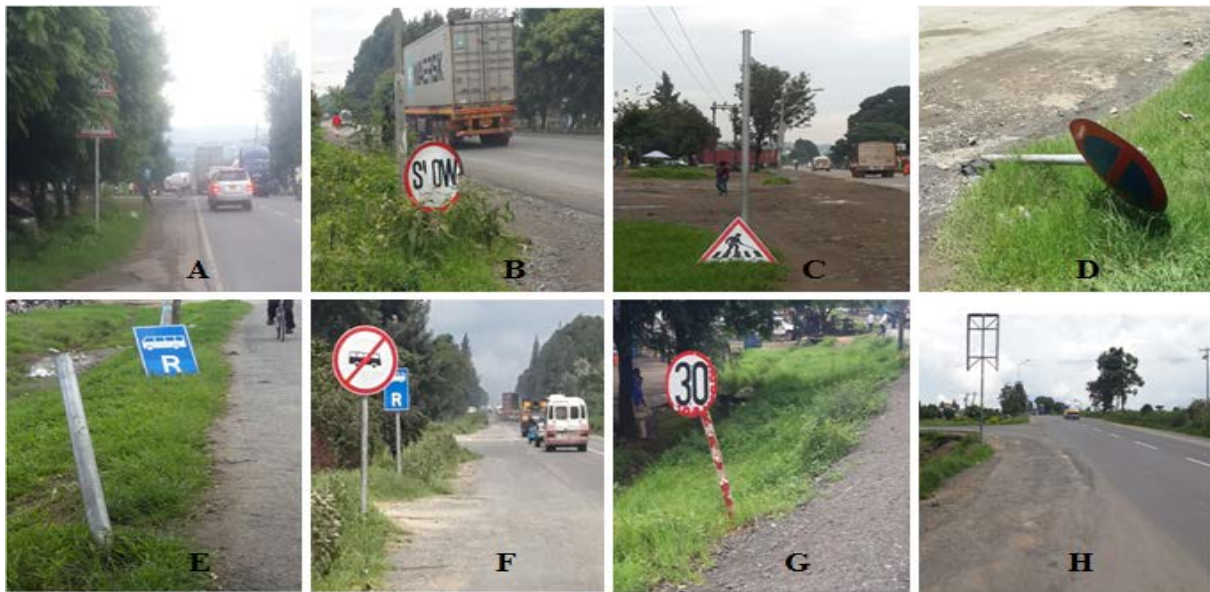
Figure 3.3: Some road signs along Uyole – Iyunga road segment having different disabilities

Figure 3.3 show photos of various road signs from Uyole to Iyunga road segment along TANZAM highway indicating different disabilities used as factors during inventory activities for analysis to determine road sign performance indices. In figure 3.3 the following disabilities were identified during road sign inventory: Photo A – a combined crossing signs for disabled (blind and wheeled persons) which is hidden from tree brunches, photo B – warning sign with defected word legend, partly hidden and under size stem, photo C – a pedestrian crossing sign with a sign board removed from a stem, photo D – knocked down a no entry sign, photo E – knocked down bus reserve sign, photo F – confused signs for no town buses (front) and town bus reserve (behind) at the same location, photo G – speed limit sign with defected sign board, bent stem which changed orientation of driving direction, photo H – missing T junction sign from both approaches. For best performance, the road signs and markings/lines should have the following properties: visible from far distance, easily and quickly understood by road users, self explanatory, retro reflective during night time, easy to make maintenance and replacement, durable and cost effective.

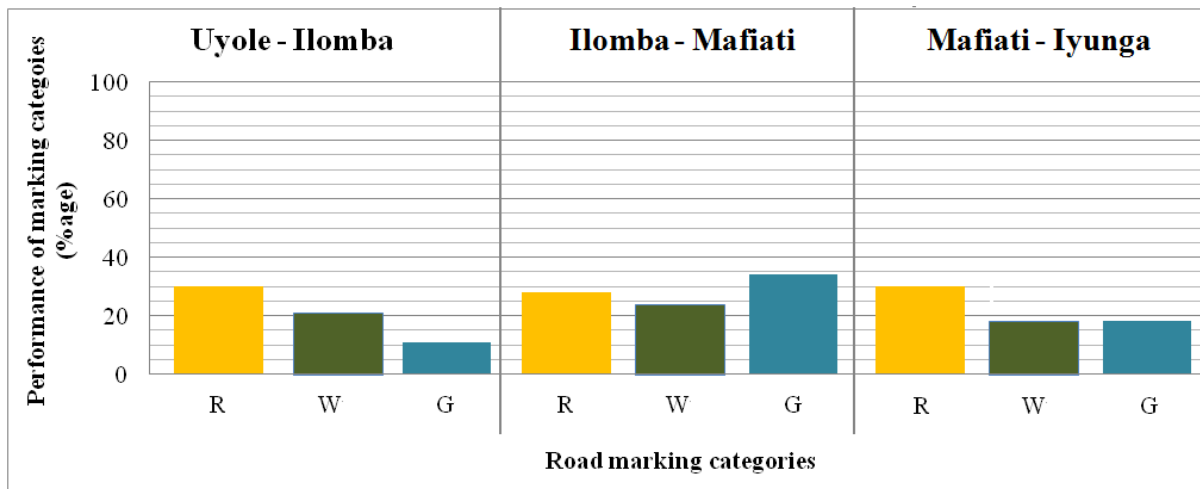
The average performance of road markings/lines from Uyole to Iyunga was determined to be fair (refer table 2.4) with a performance index (RMPI) of 1.19. The performance of road markings/lines for respective road sections, Uyole to Ilomba, Ilomba to Mafiati and Mafiati to Iyunga were determined to be fair with performance indices of 1.04, 1.42 and 1.10 respectively. However the performance of individual road marking categories for the three road sections are less than fifty percent (figure 3.4) which requires immediate maintenance and replacement as it is not safe for traffic operation along road segment.

Figure 3.4: Some road signs along Uyole – Iyunga road segment having different disabilities

This is because it becomes difficult for drivers to detect safe places for overtaking slow moving vehicles and lane changing, quick identification of location for pedestrians, schools and animals crossing, quick response for turning direction and safety driving of far lanes due to edge drop-offs and other road defects. Such situations reduce comfortability and driving confidence especially during night time and heavy rainfall conditions which may result into accidents and vehicle crushes [21, 22].

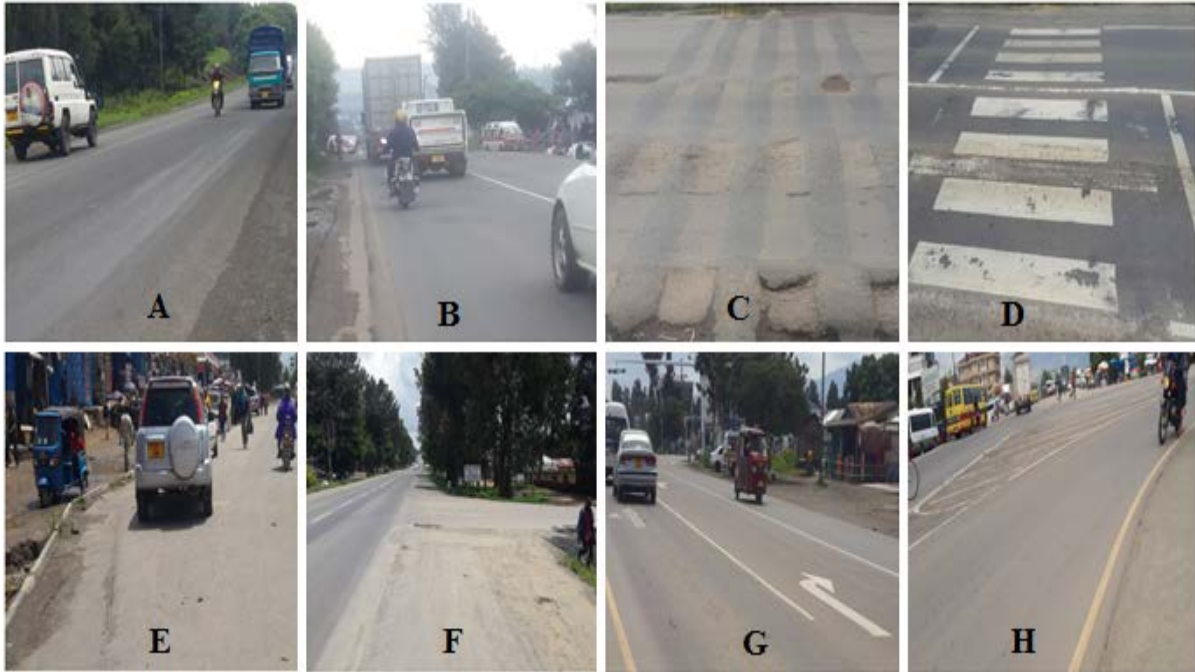
Figure 3.5 show photos of various road markings and lines from Uyole to Iyunga road segment along TANZAM highway indicating different disabilities used as factors during inventory activities for analysis to determine road markings/lines performance indices.

Figure 3.5: Some road markings along Uyole – Iyunga road segment having different disabilities

During inventory of road markings and lines the following disabilities shown in figure 3.5 were identified: Photo A – missing edge and lane/centre lines, photo B – worn out edge and faint center lines, photo C – worn out and defected rumble strips, photo D – worn out pedestrian crossing, photo E – kerbstone covered with mud and missing kerbstone face marking, photo F – missing right and left turning arrows, photo G – faint turning arrow at intersection, photo H – faint lines for channelized island at intersection.

Investigation revealed that the current condition of road markings from Uyole to Iyunga along TANZAM highway requires immediate maintenance and replacement as their average condition is fair with performance index of 1.19 (23.8%). The performance of road marking was low and did not reach 50% average. The road markings were characterized with poor reflectivity due to worn out markings from vehicle tires and aging, several location of missing road marking and lines due to maintenance of road defects and overlays, missing and unpainted kerbstones. The performances of individual marking categories were found to be 29.2% for regulatory markings, 21.1.0% for warning markings and 21% for guidance markings. From the performance results of road marking for the case of this study it is recommended that whenever there is a plan to conduct pavement maintenance or overlays, the plan should include replacement of markings/lines. This is because most of road maintenance and overlay programs in Tanzania do not include replacement and maintenance of road markings and signs except for major rehabilitation and reconstruction.

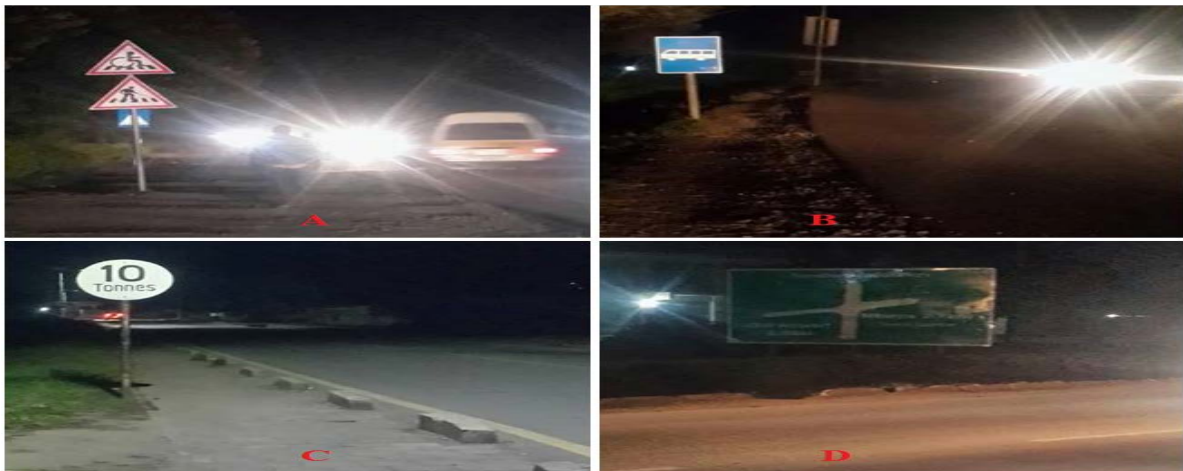
Figure A: Reflectivity of some road signs along Uyole - Iyunga road segment

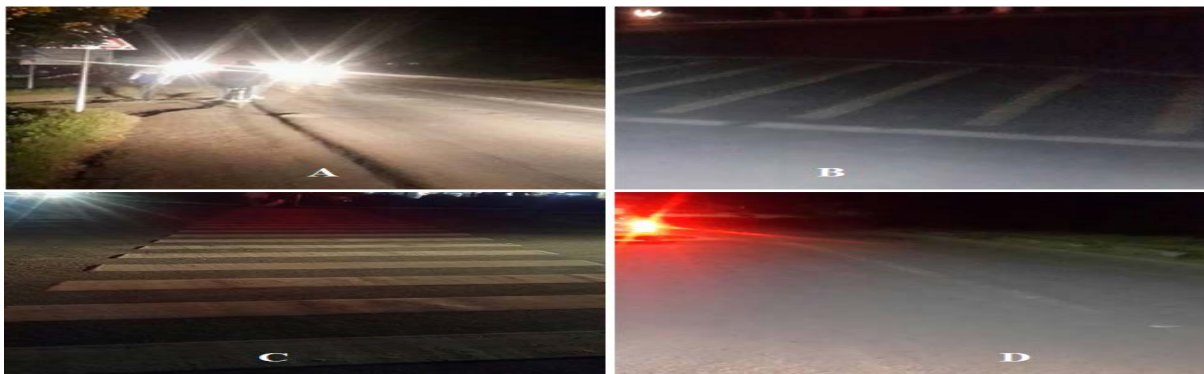
Figure B: Reflectivity of some road markings and lines along Uyole – Iyunga road segment
