Study on the Effects of Pavement Condition on Level of Service of the Road Segments

Abstract

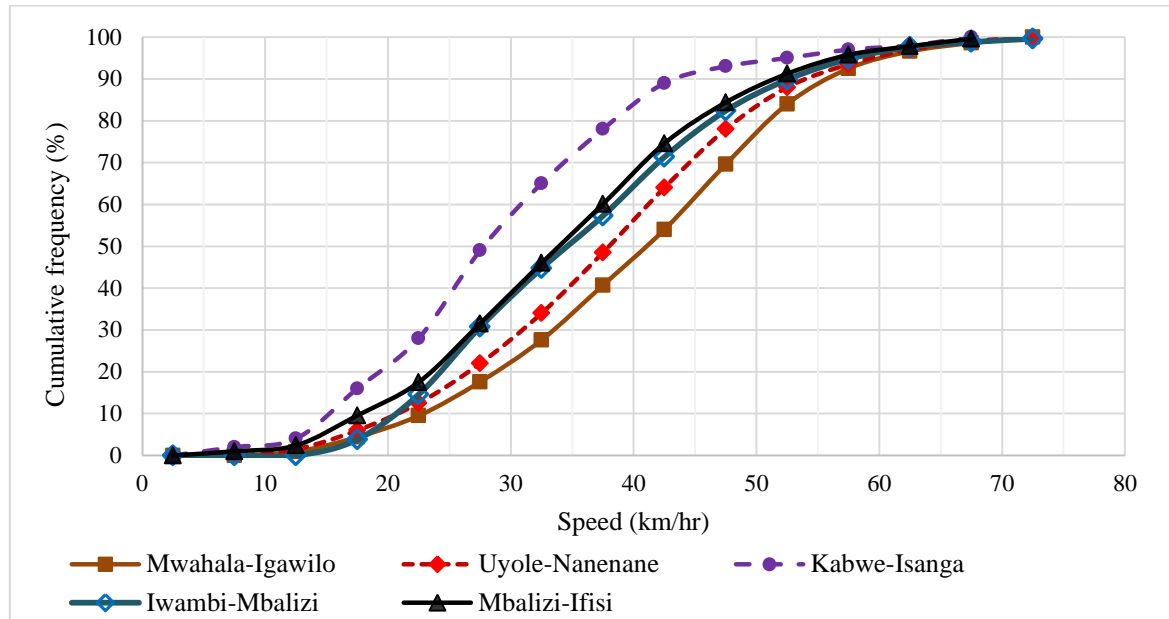
Figure 1: Vehicle speed curves for selected five road segments

using stop watch for each vehicle crossing a distance of 100m at specified visible location along each selected road segment. The speed of each vehicle were computed by dividing the distance with time taken and the frequency distribution curves were drawn as described in Manual of Transportation Engineering Studies [16]. The average travel speeds or median speed of vehicles were computed as 50 percentiles from the cumulative frequency – speed curves [17]. The average speeds computed for each road segments are Igawilo–Mwahala was 41km/h (26mil/hr), Kabwe–Isanga was 28km/h (17mil/h), Nanenane–Uyole was 38km/h (24mil/hr), Mbalizi–Ifisi was 34km/hr (21mil/hr) and Iwambi–Mbalizi was 35km/h (22mil/h). Figure 1 shows cumulative frequency – speed curves for selected five road segments for this study.

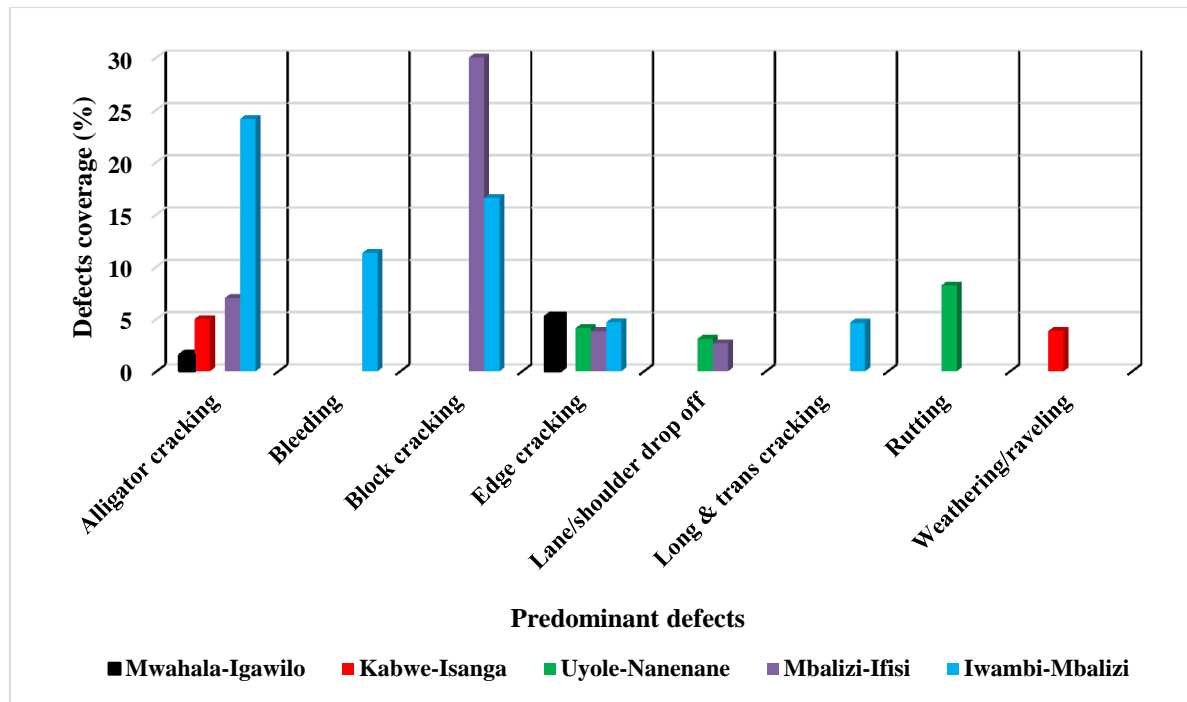
Figure 4: Summary of amount of predominant defects along the five road segments.

The predominant defects for Mwahala–Igawilo road segment is edge cracking which cover 5% of the total area, Kabwe–Isanga are alligator cracking which covers 5.2% and weathering/raveling which covers 4% of the total area, Uyole–Nanene are rutting which covers 8.2%, edge cracking which covers 4.1% and lane/shoulder drop off which covers 3.1% of the total area, Mbalizi–Ifisi are block cracking which covers 30%, alligator cracking which covers 7% and edge cracking which covers 3.8% of the total area and Iwambi–Mbalizi are alligator cracking which covers 24.1%, bleeding which covers 11.3%, block cracking which covers 16.6%, edge cracking which covers 4.6% and longitudinal/transverse cracking which covers 4.6% of the total area.

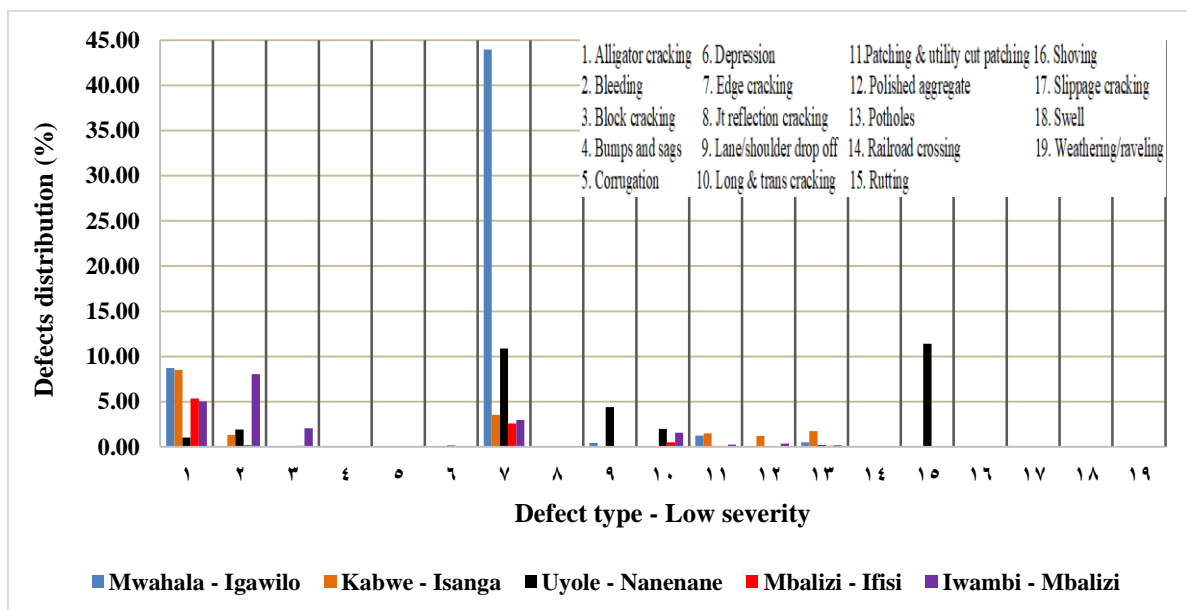
Figure 5: Charts of percentages distribution of defects for low severity and road segments

It is important to determine percentage distribution of the defects found along the road segment in order to know the type of dominant defects and their severity. This will assist road agencies and decision makers to plan for maintenance budgets and use appropriate methodology to treat particular defects. This is because each defects and its severity level can be treated with different methodology which may affect budgets for equipment/tools, laborers and materials. Figure 5 shows histograms of defects percentage distribution for low severity along the five selected road segments.

For Mwahala – Igawilo road segment the defects with high distribution are edge cracking and alligator cracking, while for Kabwe – Isanga are alligator cracking and edge cracking, for Uyole – Nanenane are rutting, edge cracking and lane/shoulder drop off, for Mbalizi – Ifisi are alligator cracking and edge cracking and for Iwambi – Mbalizi are alligator cracking, bleeding, block cracking and edge cracking.

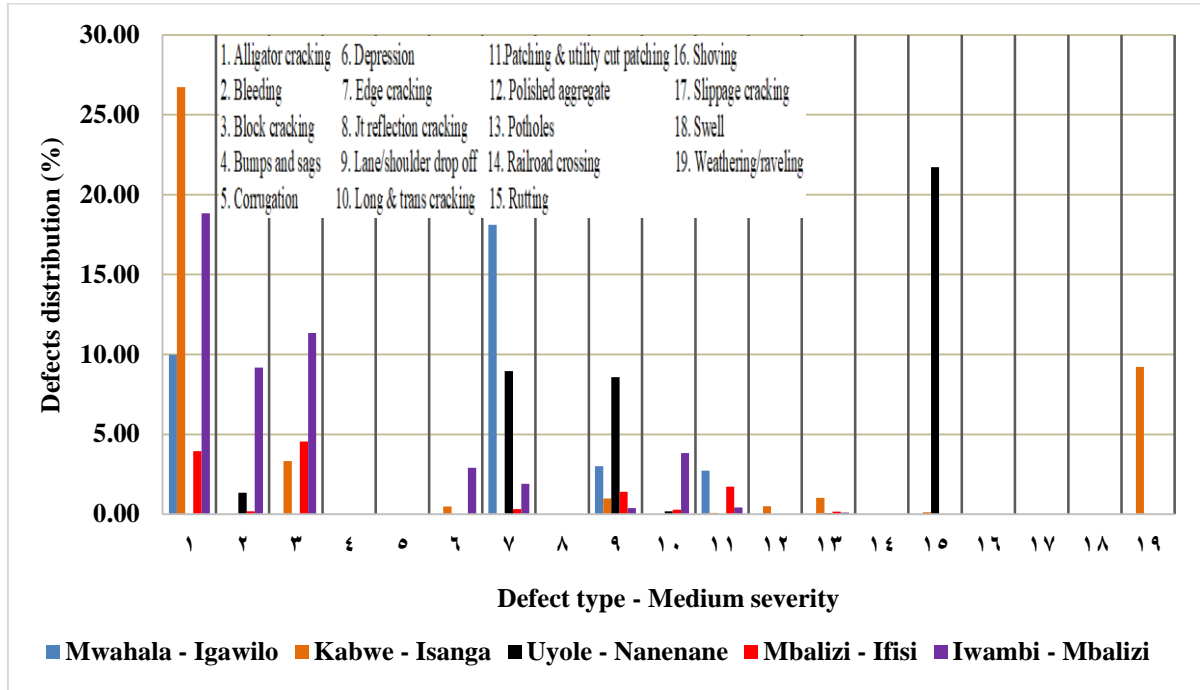
Figure 6: Charts of percentages distribution of defects for medium severity and road segments

Figure 6 shows histograms of defects percentage distribution for medium severity along the five selected road segments. For Mwahala – Igawilo road segment the dominant defects are alligator cracking and edge cracking, while for Kabwe – Isanga are alligator cracking and weathering/raveling, for Uyole – Nanenane are rutting, edge cracking and lane/shoulder drop off, for Mbalizi – Ifisi are alligator cracking and block cracking and for Iwambi – Mbalizi are alligator cracking, bleeding and block cracking. Figure 7 shows histograms of defects percentage distribution for high severity along the five selected road segments. The dominant defects found along Mwahala – Igawilo road segment is lane/shoulder drop off, while for Kabwe – Isanga are patching and utility cut patching and weathering/ravelling, for Uyole – Nanenane are edge cracking, lane/shoulder drop off and rutting, for Mbalizi – Ifisi are alligator cracking, block cracking, edge cracking and lane/shoulder drop off and for Iwambi – Mbalizi are alligator cracking and bleeding.

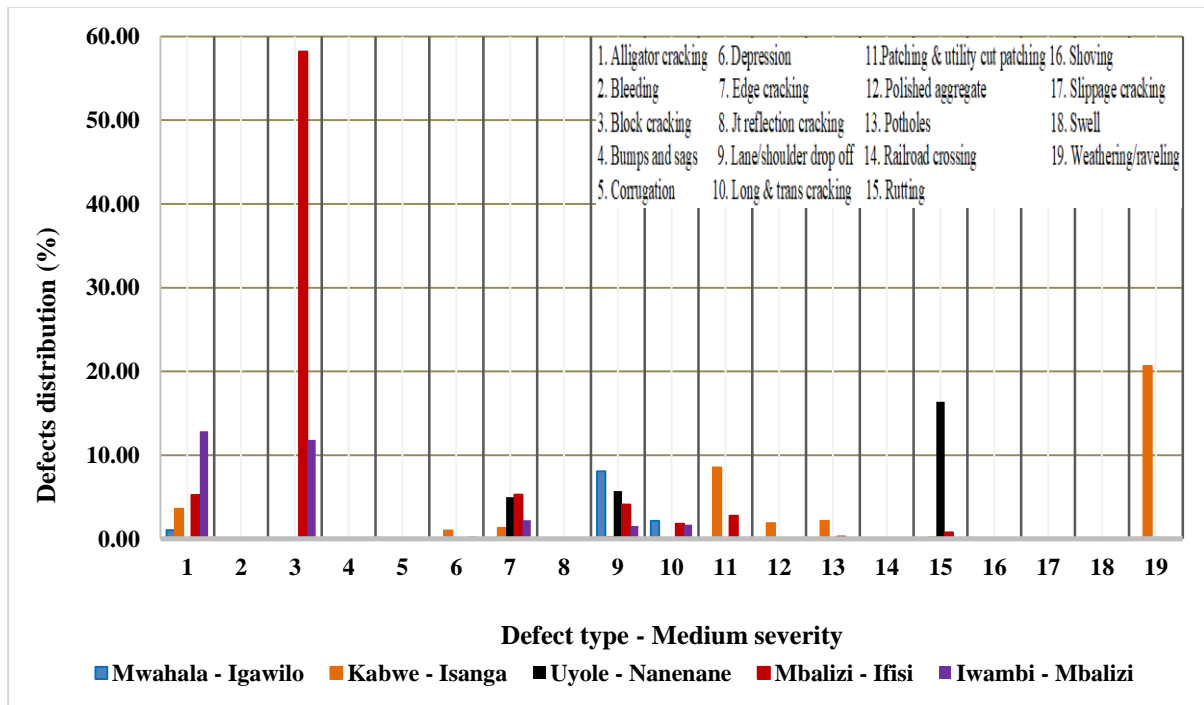
Figure 7: Charts of percentages distribution of defects for high severity and road segments

The percentage distribution for road defects along road segments for each severity levels for this study were computed based on the quantities of the defects found regardless of different unit of measurements. The unit of measurement for different defects are different in which some are measured in area such as alligator cracking, rutting, bleeding, others in number such as potholes and others in linear such as longitudinal and transverse cracking, edge cracking [1, 13, 18].

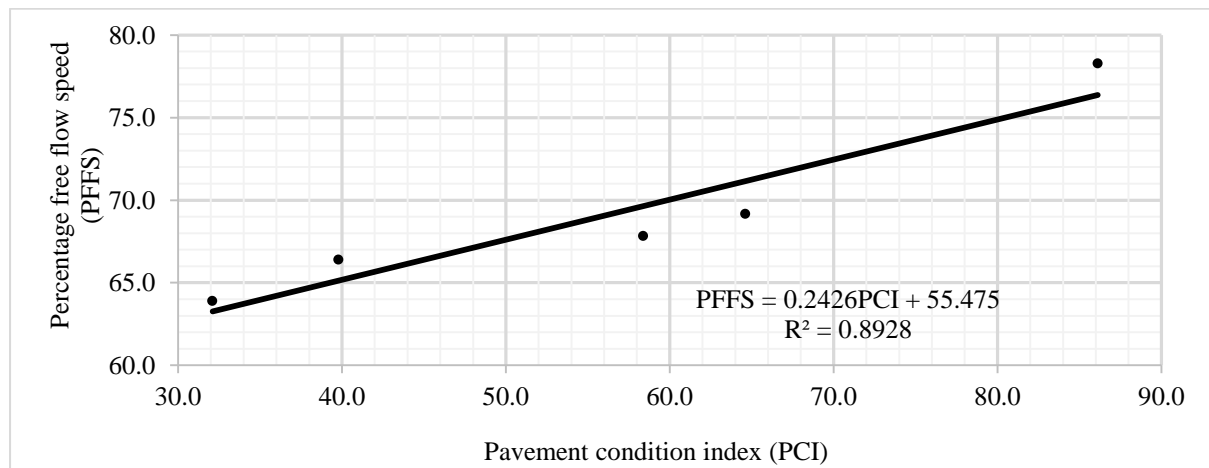
Figure 8: Graph of PFFS and PCI values for the five selected road segments

The values of percent free flow speeds (PFFS) and pavement condition indices (PCI) for each five road segments were used to determine their relationship. Table 8 gives the values of PFFS representing the level of services (LOS) of two-lane class III highways and pavement condition indices (PCI) representing level of deterioration of pavement surfaces. The poor riding comfort and performance of traffic operation along a road segment caused by travelling delays, difficult to overtake and maneuver, traffic congestion/jam, accidents and high vehicle operation costs are very much influenced by level of pavement deterioration. Figure 8 is a graph showing the relationship between PFFS and PCI of the five road segments.

For this study the effects of pavement condition index (PCI) on level of service (LOS) of the two-lane class III highways have been expressed by equation 6. The percent free flow speed (PFFS) is the measure of LOS.

$$PFFS = 0.243PCI + 55.5 \quad (6)$$

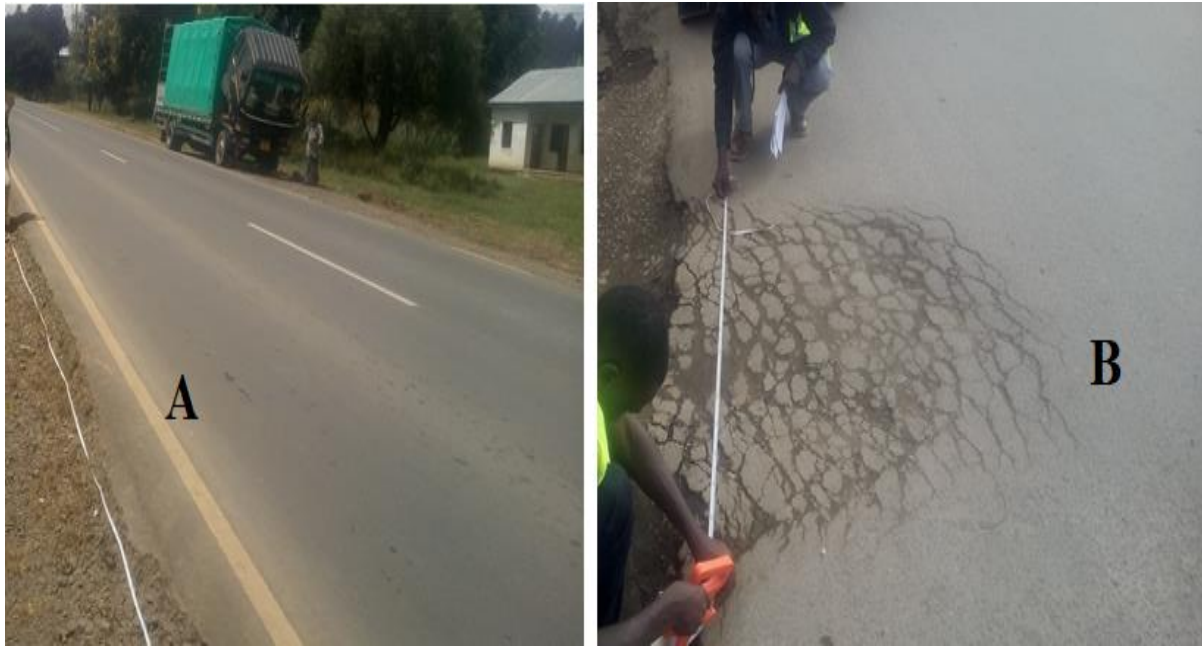
Figure A1: Edge cracking (left) and alligator cracking and edge cracking (right) for Mwahala–Igawilo road segment

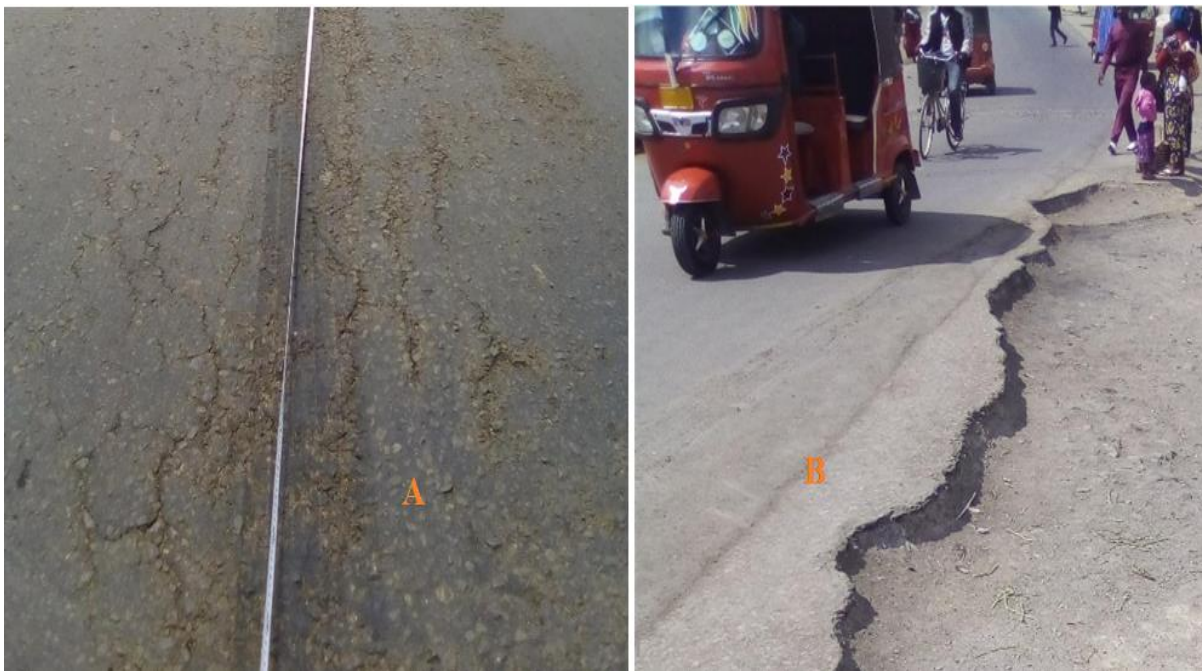
Figure A2: Alligator cracking (left) and edge cracking (right) for Kabwe–Isanga road segment

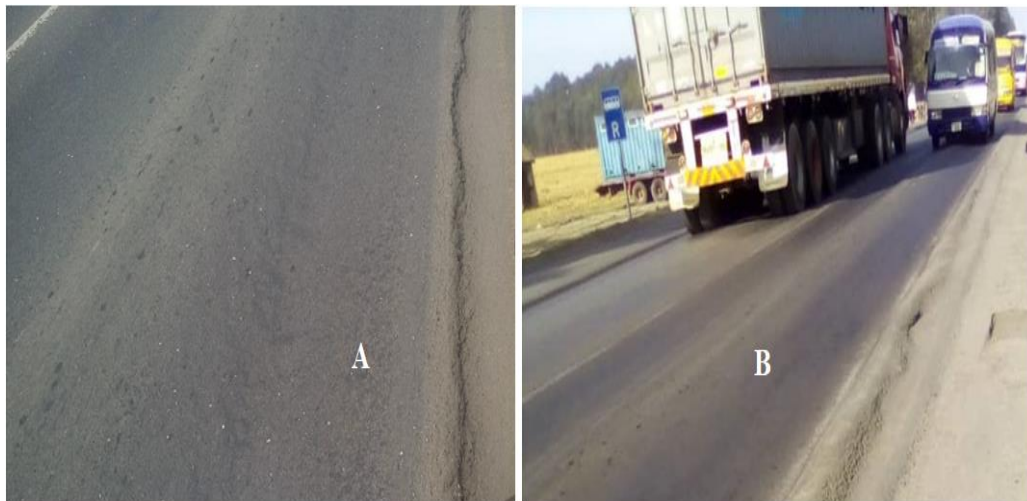
Figure A3: Rutted pavement surface for Nanenane–Uyole road segment

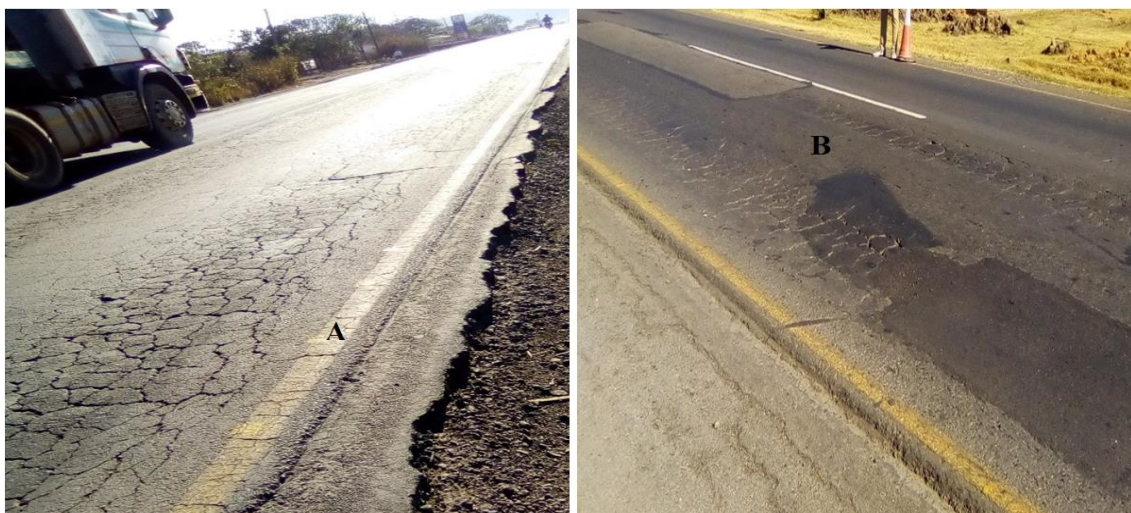
Figure A4: Alligator and edge cracking (left) and alligator cracking and patching (right) for Mbalizi–Ifisi road segment

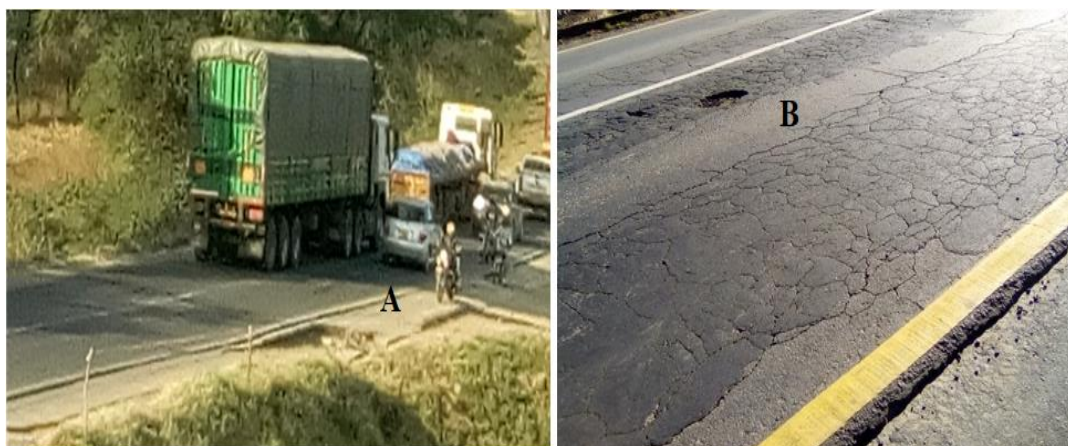
Figure A5: Edge cracking (left) and alligator cracking and pothole (right) for Iwambi–Mbalizi road segment
