## Problems of Boğaçayı Watershed and Watershed Management Recommendations in Resolving These Problems

Nilüfer YAZICI<sup>a\*</sup>, Süleyman KARAGÜL<sup>b</sup>

<sup>a</sup> Süleyman Demirel University, The Faculty of Forestry, Isparta, 32260, Turkey

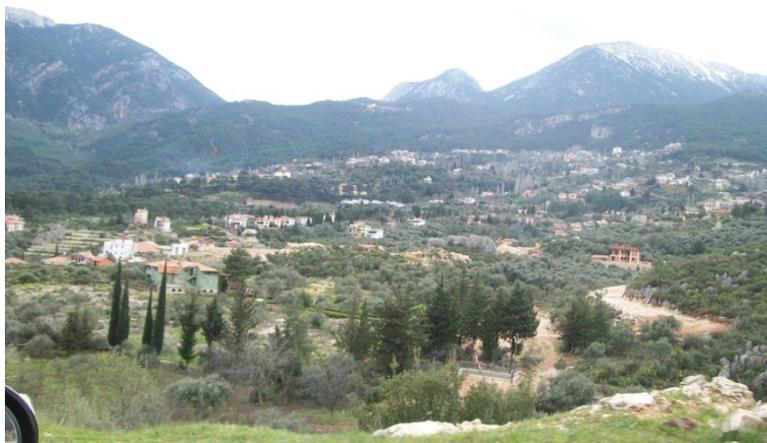
Rapid population growth in Antalya province has primarily led to unplanned urbanization and as a result of this, it caused time-consuming and insolvable problems such as squatting and urban sprawl (Figure 2).

Fig. 2. Within a watershed developing construction

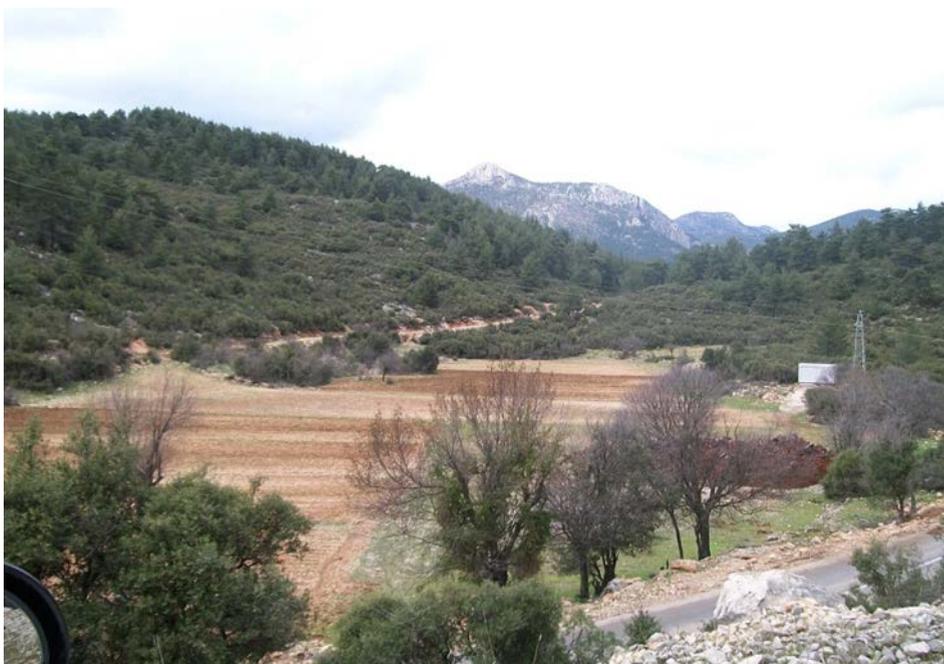
It is noteworthy that forestry areas in upper part of Boğaçayı Watershed are devastated with the reasons such as opening fields, excessive and premature grazing and forest fires. (Figure 3). However, carstic areas with fully devastated forest cover have taken a bare and stony-rocky look. Scrub community has become widespread on the areas where calabrian forests are devastated or over-operated and especially overgrazing is continued.

Fig. 3. Open field in the forest area

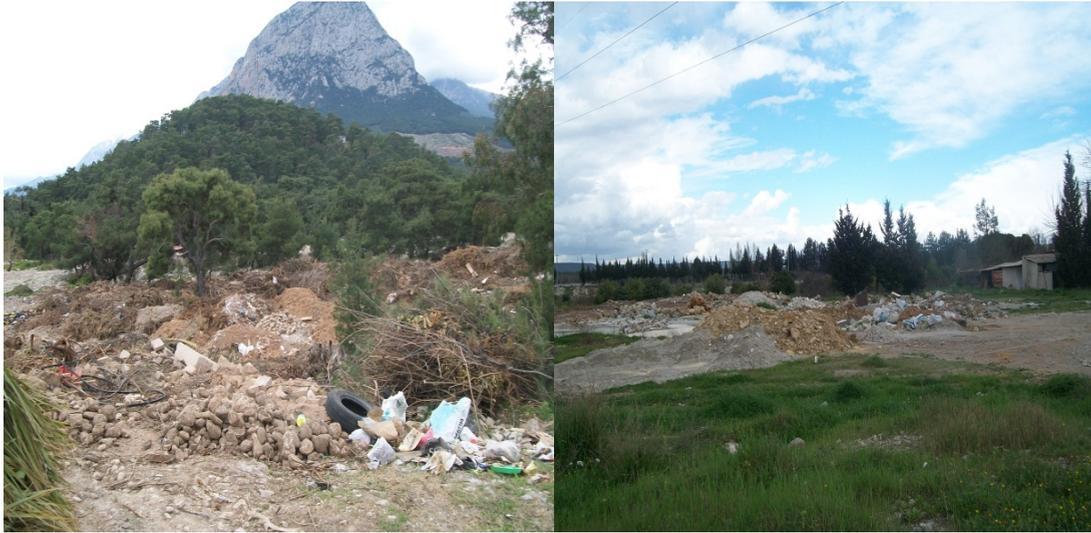
The majority of tourism centers located within the borders of watershed is small residential area having low annual revenue. Solid waste volume generated is increasing in parallel with two-folded populations of these districts and villages in summer season. (Figure 4).

Fig. 4. Within a watershed solid waste

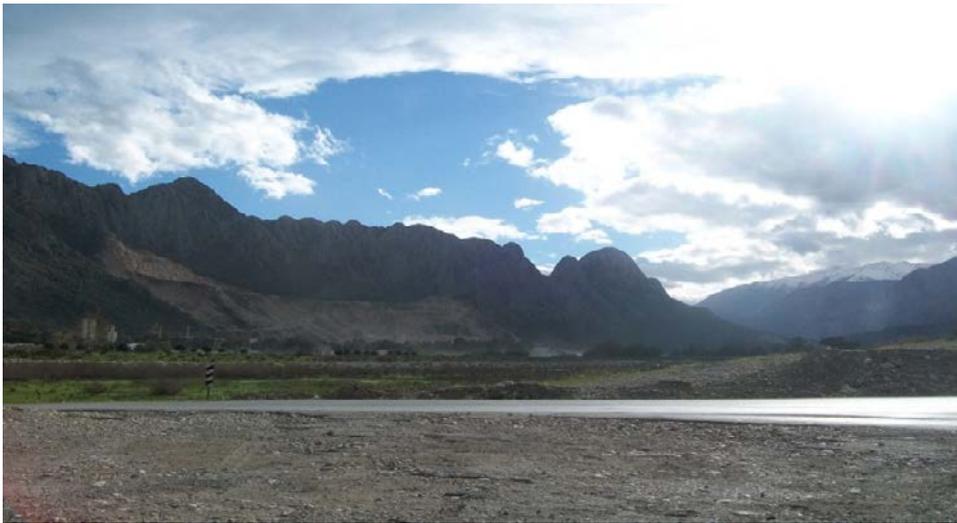
Environment is covered with lime dust as a result of operations in quarries and a unsightly landscape is created with these operations. (Figure 5). Furthermore, dusts emerged from the quarries near to road comes on the road and when these dusts are get wet with light rain or water, road becomes extremely slippery. And this case constitutes a dangerous situation for drivers.

Fig. 5. Caused by quarry dust clouds

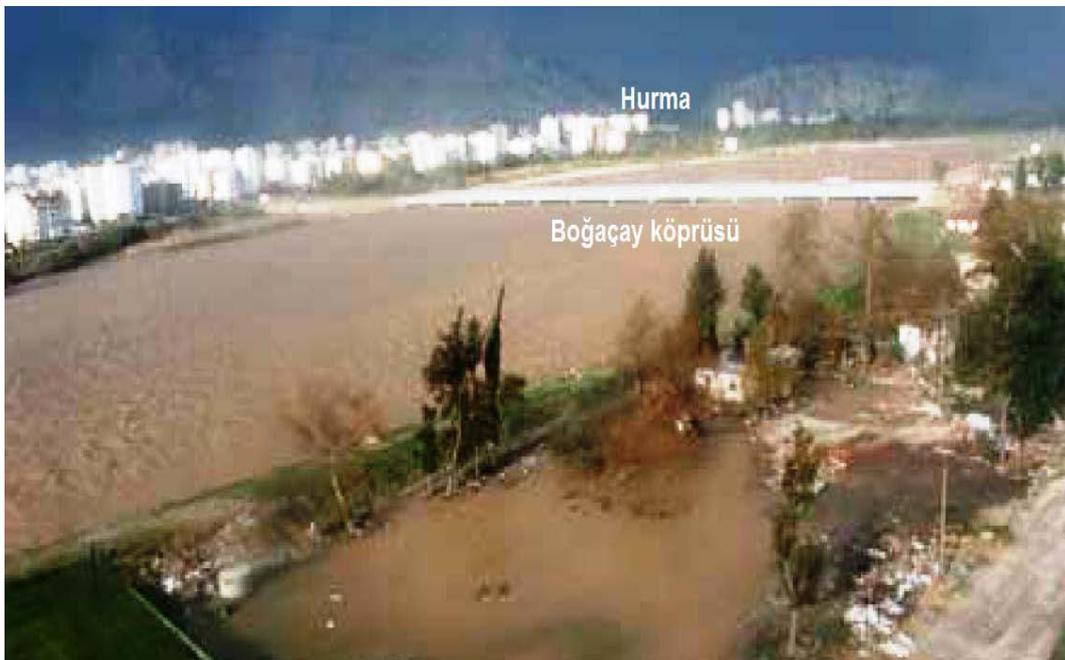
It has been witnessed that unplanned material procurements without permission from beds of sand-gravel quarries and brooks as a result of land observations conducted in Boğaçayı Watershed cause disruptions in river beds. In addition to this, vegetation in the vicinity of bedding is gradually removed. This situation adversely affects ecology of the basin. Therefore, residential areas in Boğaçayı Watershed are exposed to risk of overflowing and flood at all times. Spreading to a vast area of materials such as rock, gravel, debris brought by flood waters and water accumulation in agricultural lands has been experienced for several times. With operations of zoning for construction, damage extents of overflowing and flood have further grown in size (Figure 6).

Fig. 6. Flood resulting image
