Study on Performance of Road Signs and Markings along TANZAM Highway in Mbeya Region, Tanzania

Duwa Hamisi Chengula*

*Mbeya University of Science and Technology, College of Engineering and Technology, Department of Built
Environment Engineering. P.o.Box 131 Mbeya, Tanzania
Email: chengula@yahoo.com*

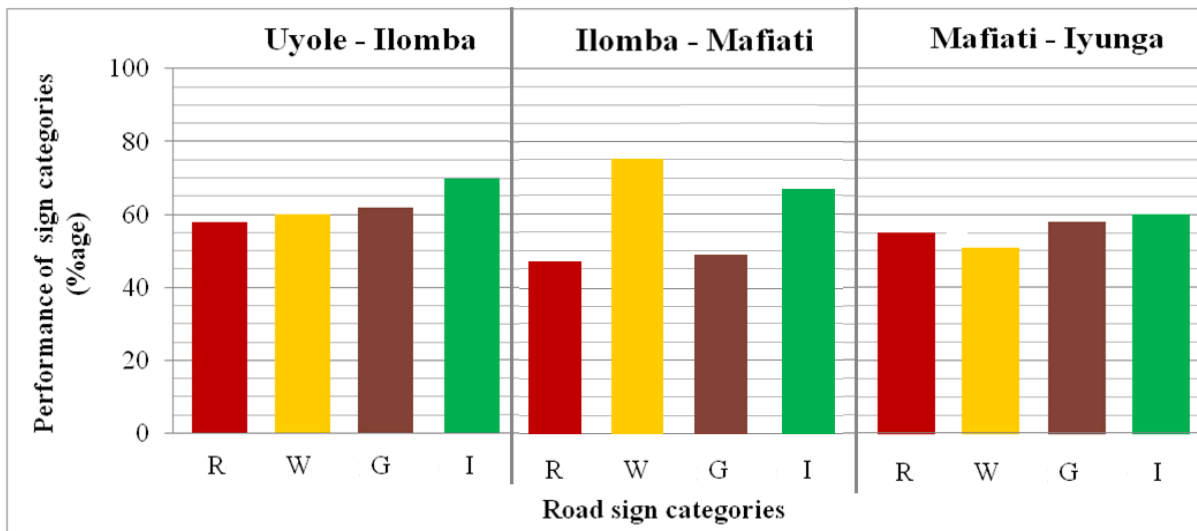
Figure 3.1: Performance of individual road sign categories for selected road sections

The average performance of road signs from Uyole to Iyunga was determined to be good (refer table 2.4) with a performance index (RSPI) of 2.96. The road signs performance for individual sections, Uyole to Ilomba was determined to be very good with an index of 3.12 while for Ilomba to Mafiati and Mafiati to Iyunga were determined to be good with performance indices of 2.97 and 2.79 respectively. The performances of individual sign categories for the three road sections are indicated in figure 3.1. The figure shows lower performance of regulatory road signs compared to other categories for the three road sections. Regulatory road signs provide the most important messages for road users. It is imperative that regulatory signs are well understood by road users for smoothly and safely navigation along the road networks but also in order the road users to obey traffic signs it is necessary the national and international road signs to be comprehensive and consistent [20].
