Use of Accelerated Tests to Estimate Corrosion Rates of Roofing Sheets

Juspher O. Ooko^a, John O. Onyatta^{b*}, Amir O. Yusuf^c, Peterson M. Guto^d

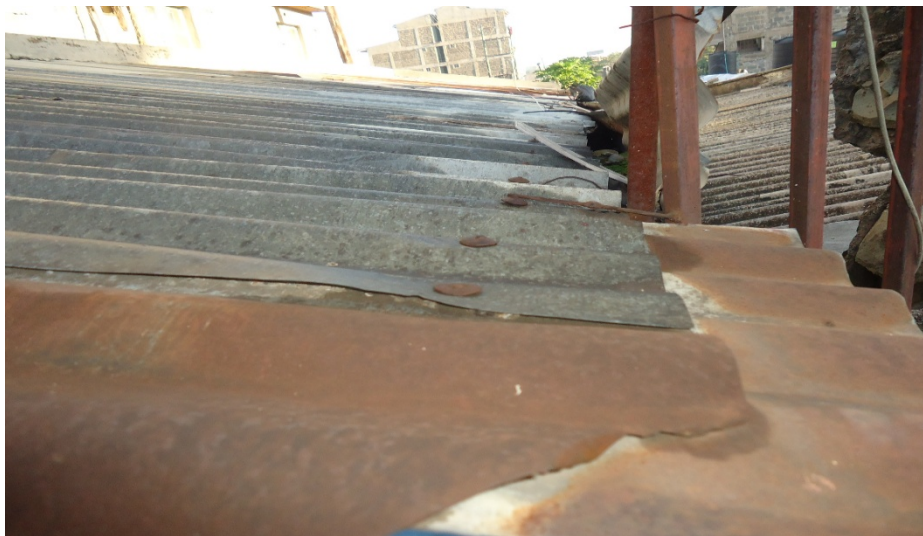
Figure 1: Corroded galvanized roofing sheets close to the Mariakani-Mombasa highway. The iron nails have turned reddish.

In Mariakani area in the coastal region of Kenya, roofing systems in most houses use galvanized (GI), galvaluminized (AZ) and pre-painted steel sheets. Hence in this study the rate of corrosion of the roofing materials was investigated based on the color change without considering the type of paint or the components. The roofing materials in Mariakani are frequently painted to prevent corrosion. A typical corroded roof in Mariakani is shown in Figure 1.

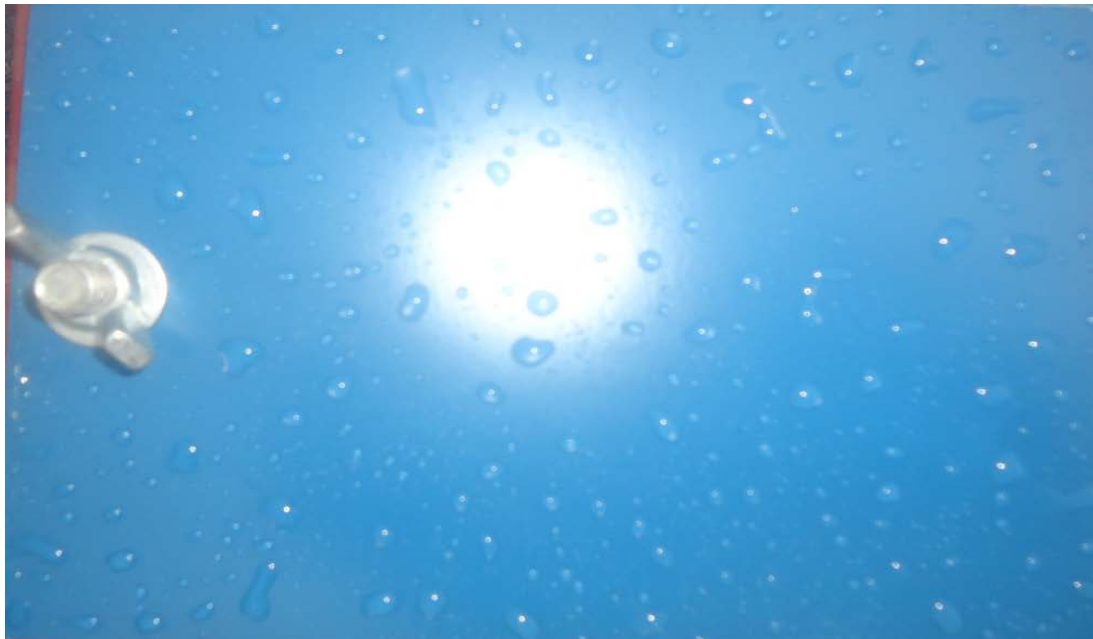
Figure 2: A Sky Blue pre-painted roofing sheet panel showing rain droplets during the time of wetness. The time of wetness is an important parameter since it directly determines the duration of electrochemical corrosion process.

The presence of moisture on the surface of the metal is known to initiate corrosion by acting as an electrolyte [6]. A typical example of droplets of moisture on the surface of a roofing panel is shown in Figure 2.

Iron sulfate is a common corrosion product in industrial atmospheres which forms layers on the steel surfaces as was shown in Figure 2. Iron sulfate is usually hydrolyzed according to equation 2 [10].

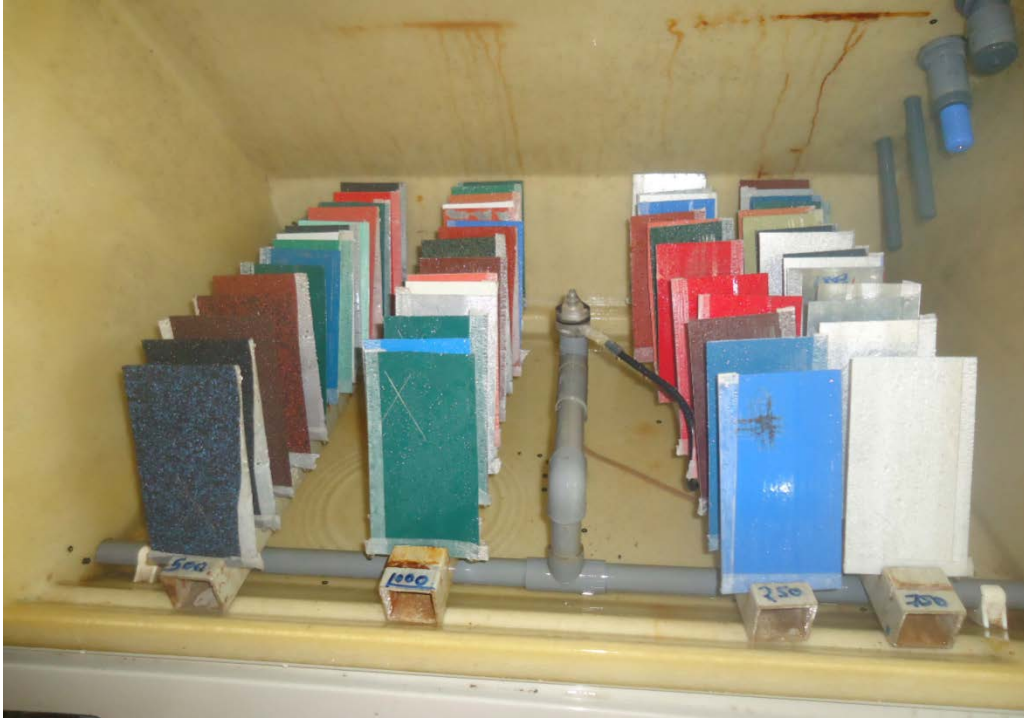
Figure 3: Arrangement of samples during salt spray (Fog) process

It is at an altitude of 203 metres above sea level, longitude 39° 27'E and latitude 03°50'S. The GI, AZ and pre-painted steel sheets measuring 150mm × 75mm were used in the accelerated tests as shown in the set up in Figure 3.

The samples were placed under ultraviolet light (Figure 3) followed by salt spray at concentrations of 0.07% NaCl and 0.28% $(\text{NH}_4)_2\text{SO}_4$. Color changes were observed within a complete cycle of 10.5 days after which the samples were cleaned with detergent, washed with acetone and dried. Spectroguide (BYK Gardner 82638, GMBH) was then used to measure gloss loss (ΔG) in % and fade (ΔE) in Hunter units for the pre-painted roofing materials.

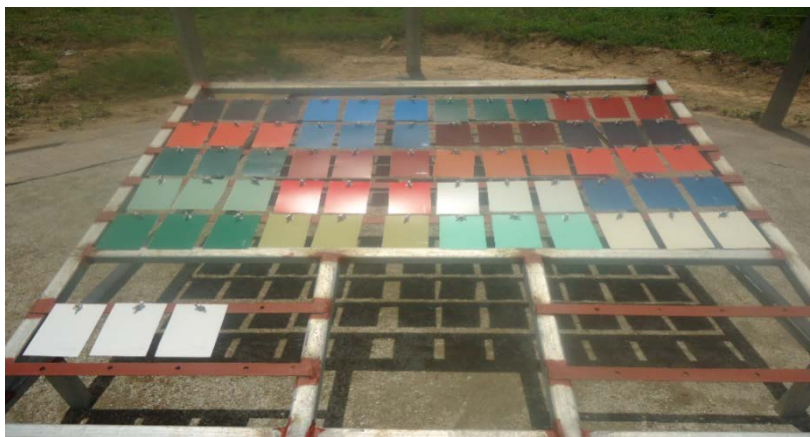
Figure 4: The pre-painted samples fastened on an exposure rack at Mariakani corrosion test site.

The samples for the outdoor exposure test were taken from a similar batch measuring 190mm \times 130mm in size and were cut using a shear cutting machine. The samples having a thickness of 0.20mm to 0.50mm were placed on the exposure rack as shown in Figure 4.
